Space Shuttle Orbiter Corrosion History, 1981-1993

A Review and Analysis of Issues Involving Structures and Subsystems

NASA Technical Memorandum 104810

**A report of the
Orbiter Corrosion Control Review Board**

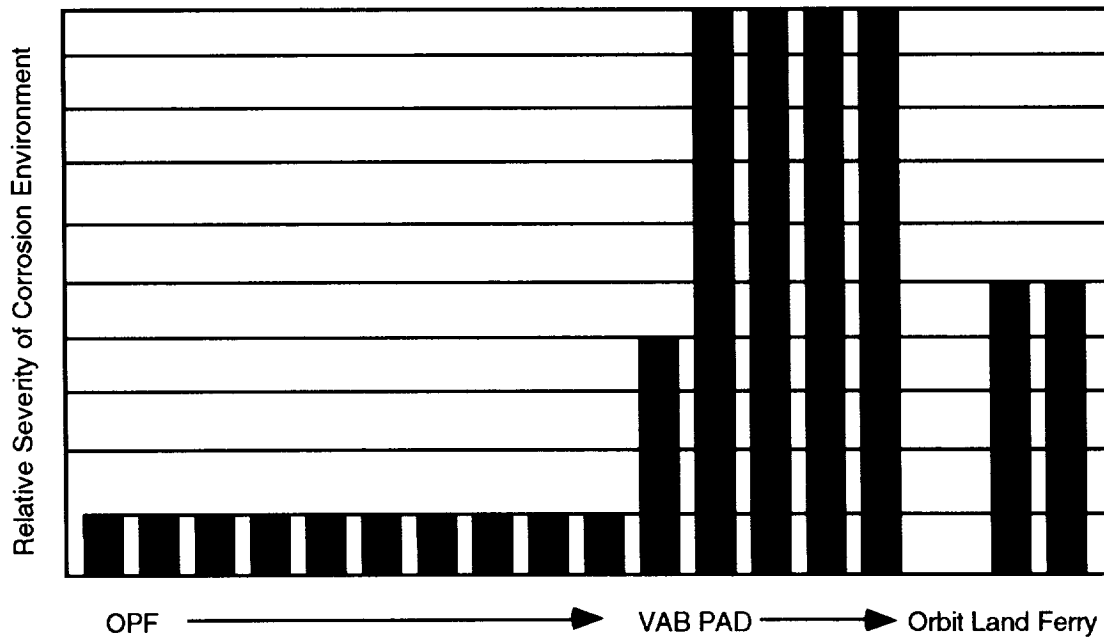
The Space Shuttle experiences corrosion environments from benign to severe as it progresses from flight to flight. The relative severity, as evaluated by the CCRB, of each environment is illustrated in figure 1. The orbiters are stored in the OPF, in which buildings are temperature- and humidity-controlled. When moved to the launch pad, each orbiter is subjected to an almost constant salt spray from the nearby Atlantic Ocean. In addition, the high humidity allows the formation of condensation on all surfaces open to the atmosphere. Once the orbiter reaches low earth orbit, any water that may have collected during earlier exposure evaporates in the vacuum of space. On landing, the orbiter must be deserviced; during this period it is exposed to whatever the environment is at the landing site. If the orbiter lands in California, it must be ferried across the country to KSC. This is additional exposure to an uncontrolled environment until the orbiter returns to the OPF. All these factors were taken into account when the overall corrosion protection scheme was developed.

Figure 1. Variation of corrosion environment during typical flow.

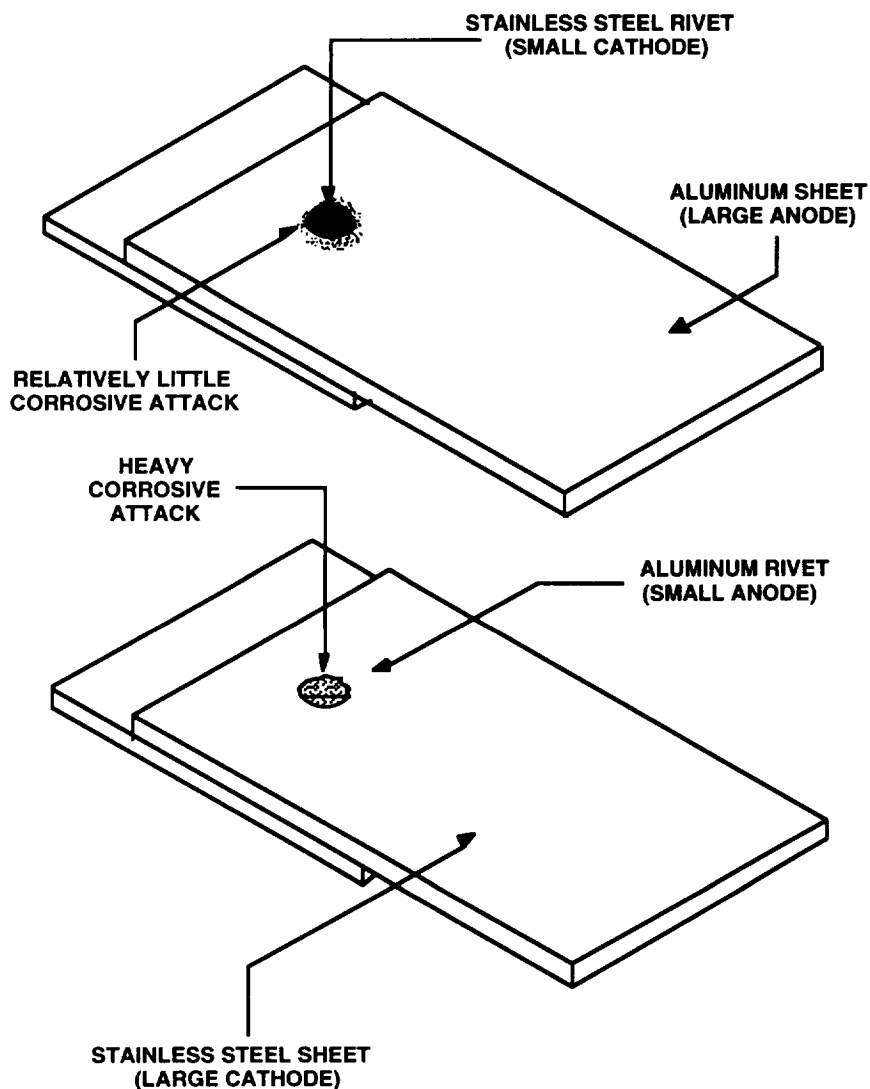
For certain configurations of structure, galvanic corrosion conditions are superimposed on atmospheric effects and most likely represent the predominant, rate-determining corrosion mechanism. Under conditions of galvanic corrosion, the cathodic counter-reaction typically occurs at a second metal which is dissimilar to the corroding anode. Furthermore, there is a marked dependence upon the relative anode/cathode area ratio, as illustrated in figure 10 [4]. Small area ratios result in accelerated galvanic attack on the anode. Most orbiter structure problems with galvanic corrosion and small anode/cathode area ratios typically occur in situations where aluminum rivets are located adjacent to stainless steel or Inconel fittings, although corrosion of the

Figure 10. Effect of area relationship in dissimilar metal contacts (from [4]).
